BRE Global Test Report

BS 8414-2:2015 + A1:2017 Test on a ventilated Marley Eternit rainscreen system with Celotex RS5000 insulation.

Prepared for: Celotex
Date: 30 April 2018
Report Number: P104852-1000 **Issue:** 1

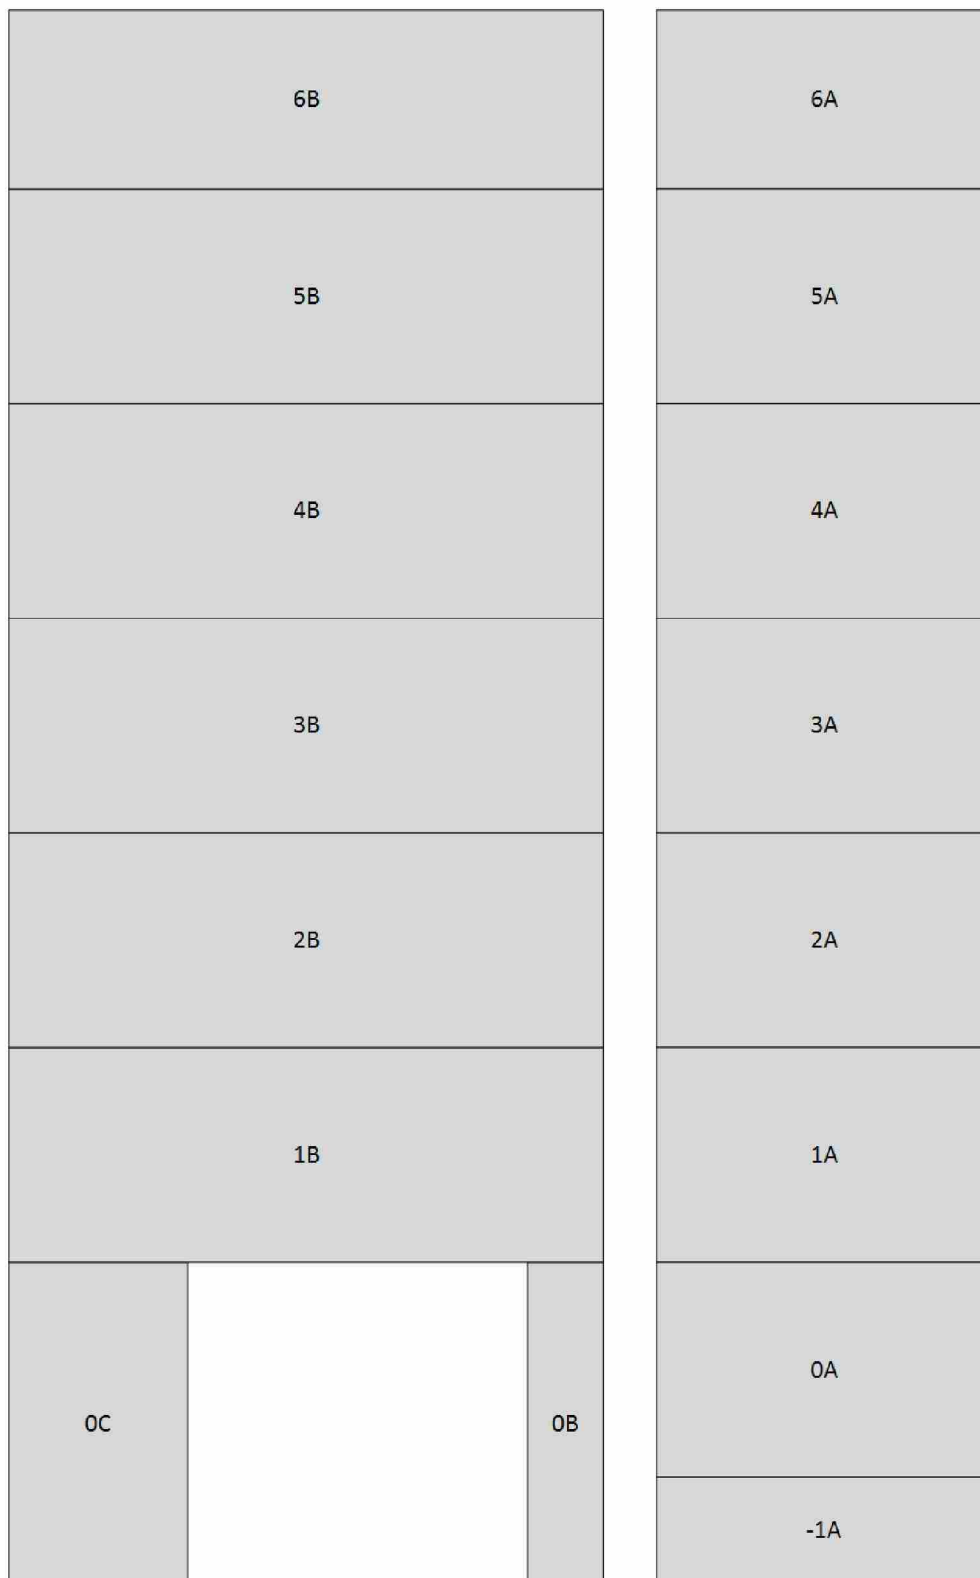
Figure 2. Layout of panels and numbering system used for reporting. Not to scale.

With reference to *Figure 2*, the damage observed to the Marley Eternit panels was as follows:

Panel 0A – 30% dark discolouration surrounded by brown discolouration, 30% pale discolouration with streaks of pale discolouration. A pattern of cracks was observed towards the main-wing wall junction.

Panel 0B – Mostly undamaged with light discolouration towards the top corner and dark discolouration towards the bottom corner adjacent to the combustion chamber opening.

Panel 0C – Mostly undamaged apart from a patch of light discolouration at the top corner adjacent to the combustion chamber opening.

Panel 1A – A patch of light discolouration (approximately 300mm-wide × 900mm-high) towards the main-wing wall junction surrounded by brown discolouration. Dark discolouration towards the edge of the wing wall. A pattern of cracks was observed towards the main-wing wall junction.

Panel 1B – Detachment of a central section approximately 800mm-wide × 1200mm-high. Light discolouration on the remainder of the panel surrounded by streaks of dark and pale discolouration. Patterns of cracks were observed on the remaining sections of the panel contained between the bounds of the combustion chamber opening.

Panel 2B – Detachment of a central section approximately 1200mm-wide × 1200mm-high. Light discolouration on the remainder of the panel surrounded by localised areas of dark discolouration. Patterns of cracks were observed on the remaining section of the panel adjacent to the wing wall.

Panel 3B – Localised areas of dark and pale discolouration covering a width of approximately 2000mm towards the main-wing wall junction. Cracks were observed near the centre of the panels.

Panel 4A – 70% minor discolouration.

Panel 4B – 5% white discolouration at base surrounded by 20% dark discolouration. 60% smoke discolouration. Cracks were observed near the base of the panels.

Panel 5A – 40% minor discolouration.

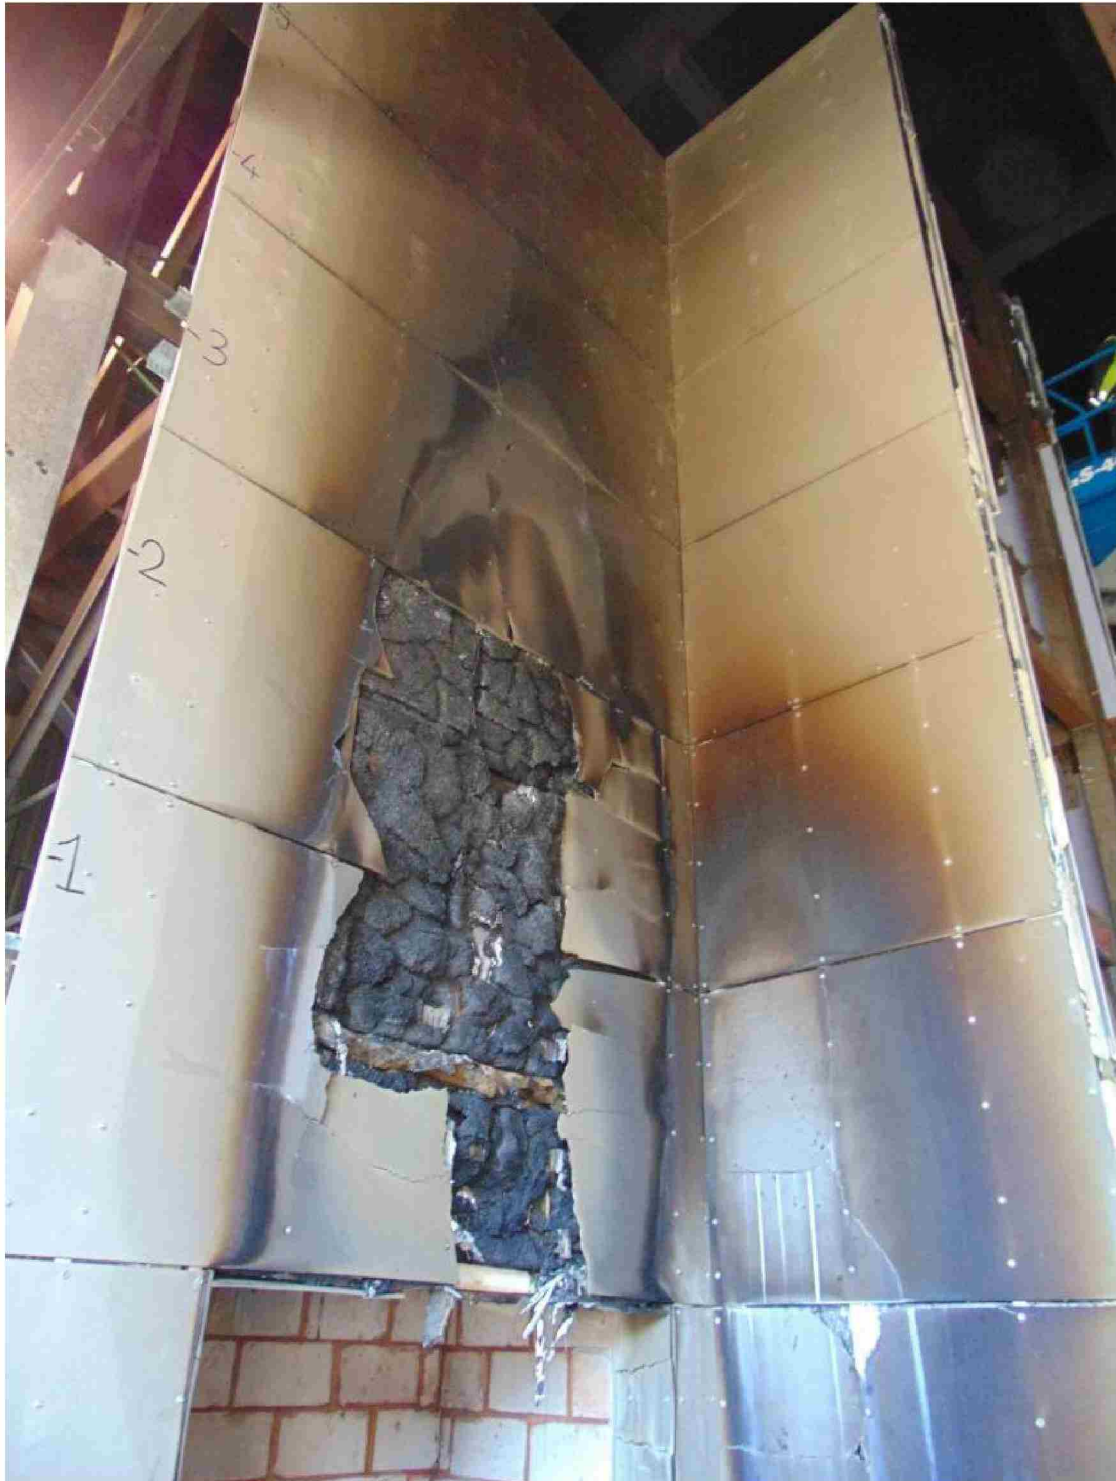
Figure 25. Post-test view of tested system from the top of the combustion chamber to the top of the cladding system.

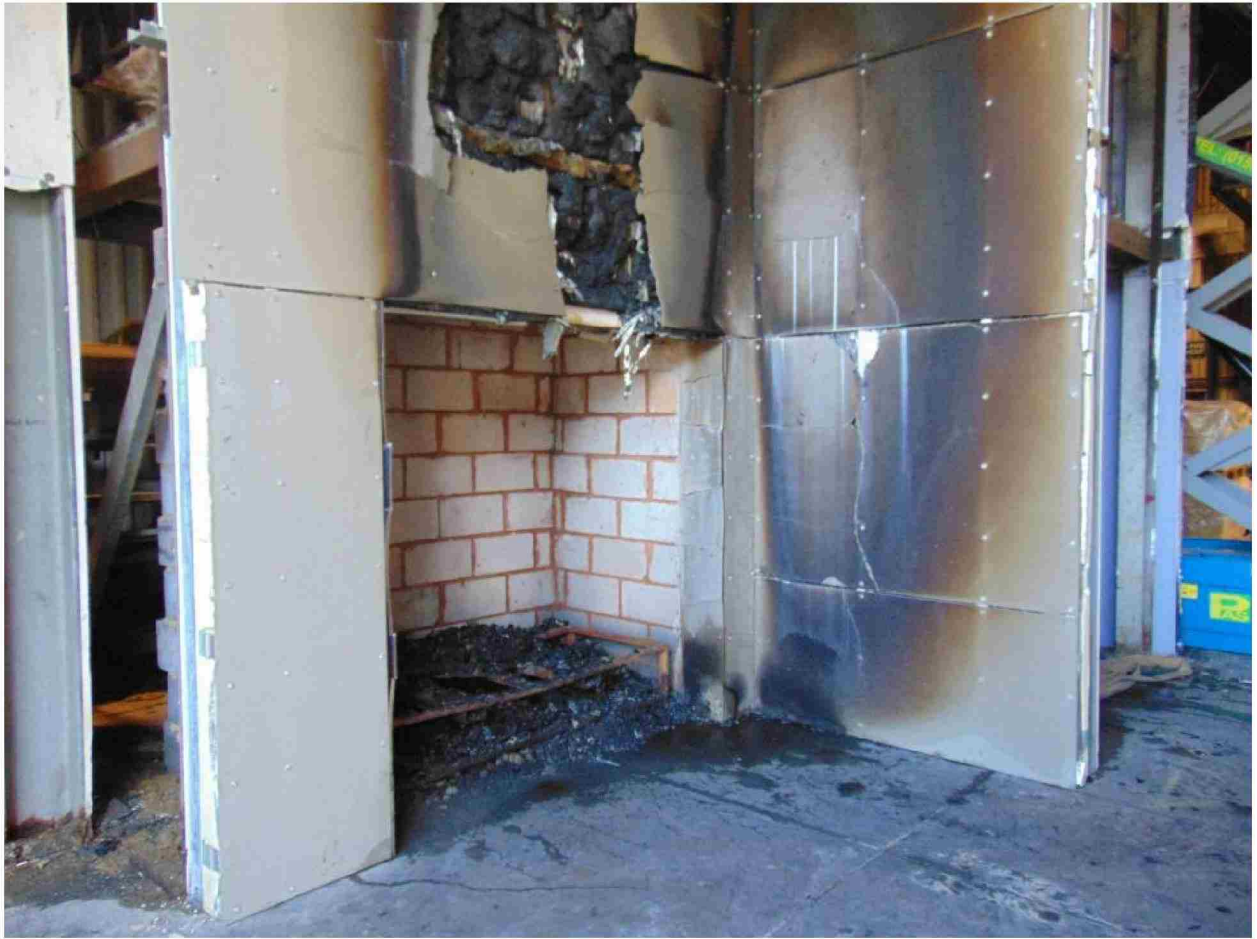
On the panels fitted to the sides of the combustion chamber there was dark discolouration towards the base of the panels with streaks of pale discolouration and localised areas of smoke discolouration. A series of horizontal cracks were observed across the height of the panels.

On the panel fitted to the top of the combustion chamber there was a section of partial detachment due to cracking approximately 500mm-wide. On the remainder of the panel there was cracking near the centre with localised areas of smoke discolouration.

Figure 26. Post-test view of panels adjacent to combustion chamber.

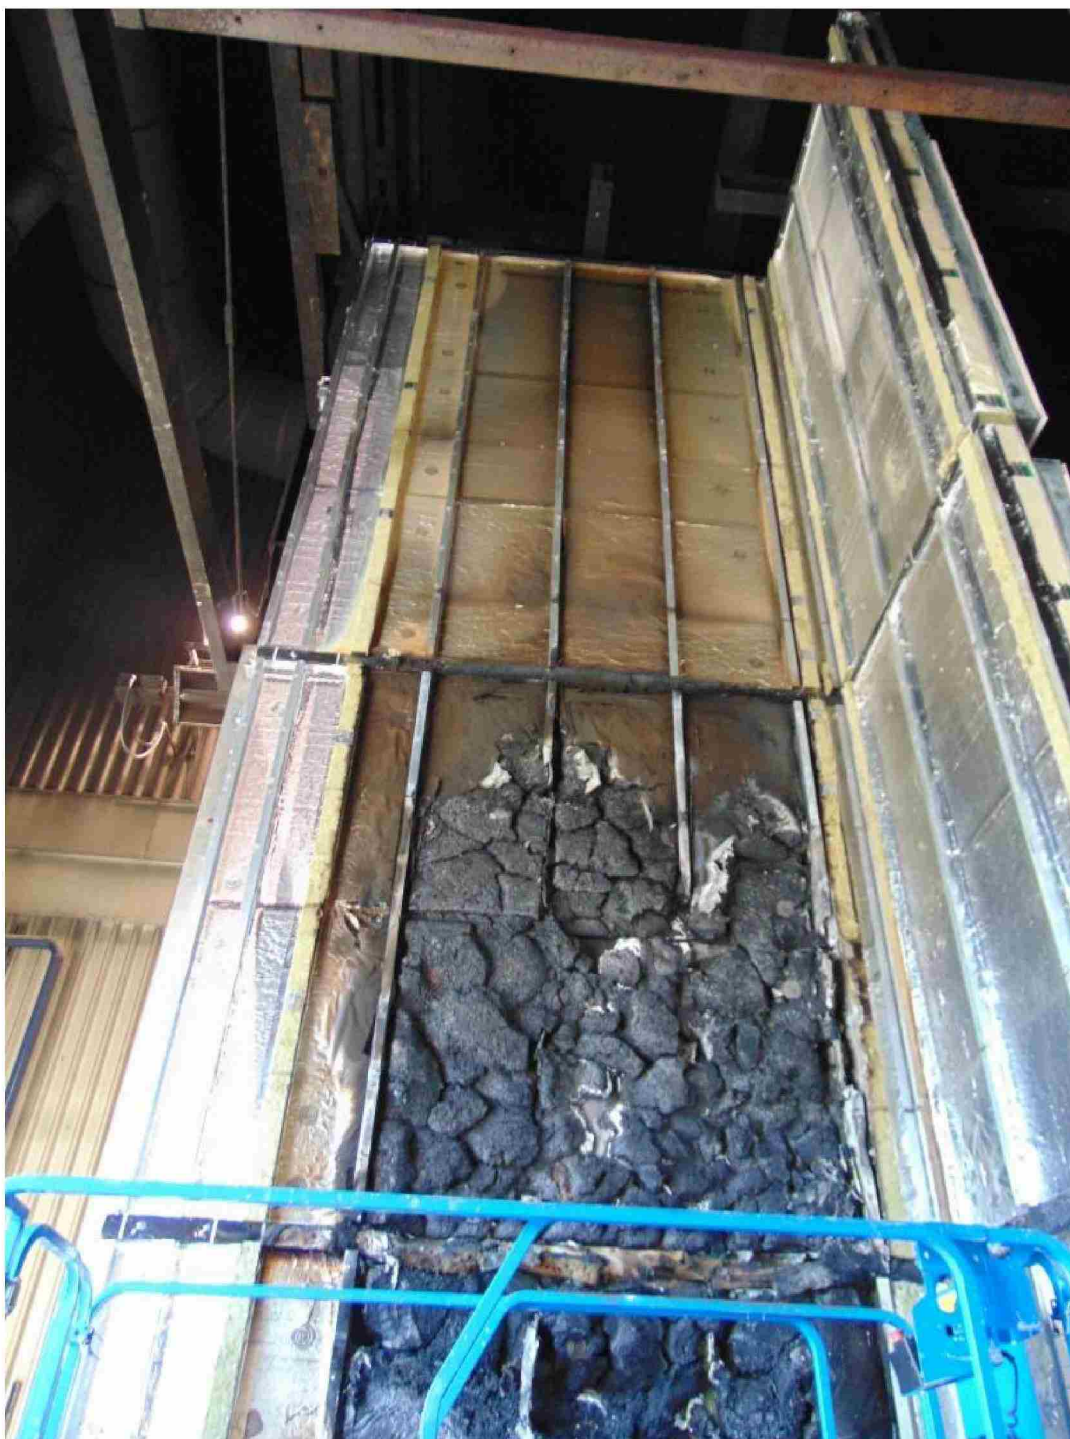
In line with the combustion chamber opening the insulation was 90% charred with localised areas of sheathing board visible. The remaining insulation had smoke staining and localised dark discolouration.

Figure 277. Post-test main wall view of insulation, rail substructure and cavity barriers from the top of the combustion chamber to the top of the cladding system.

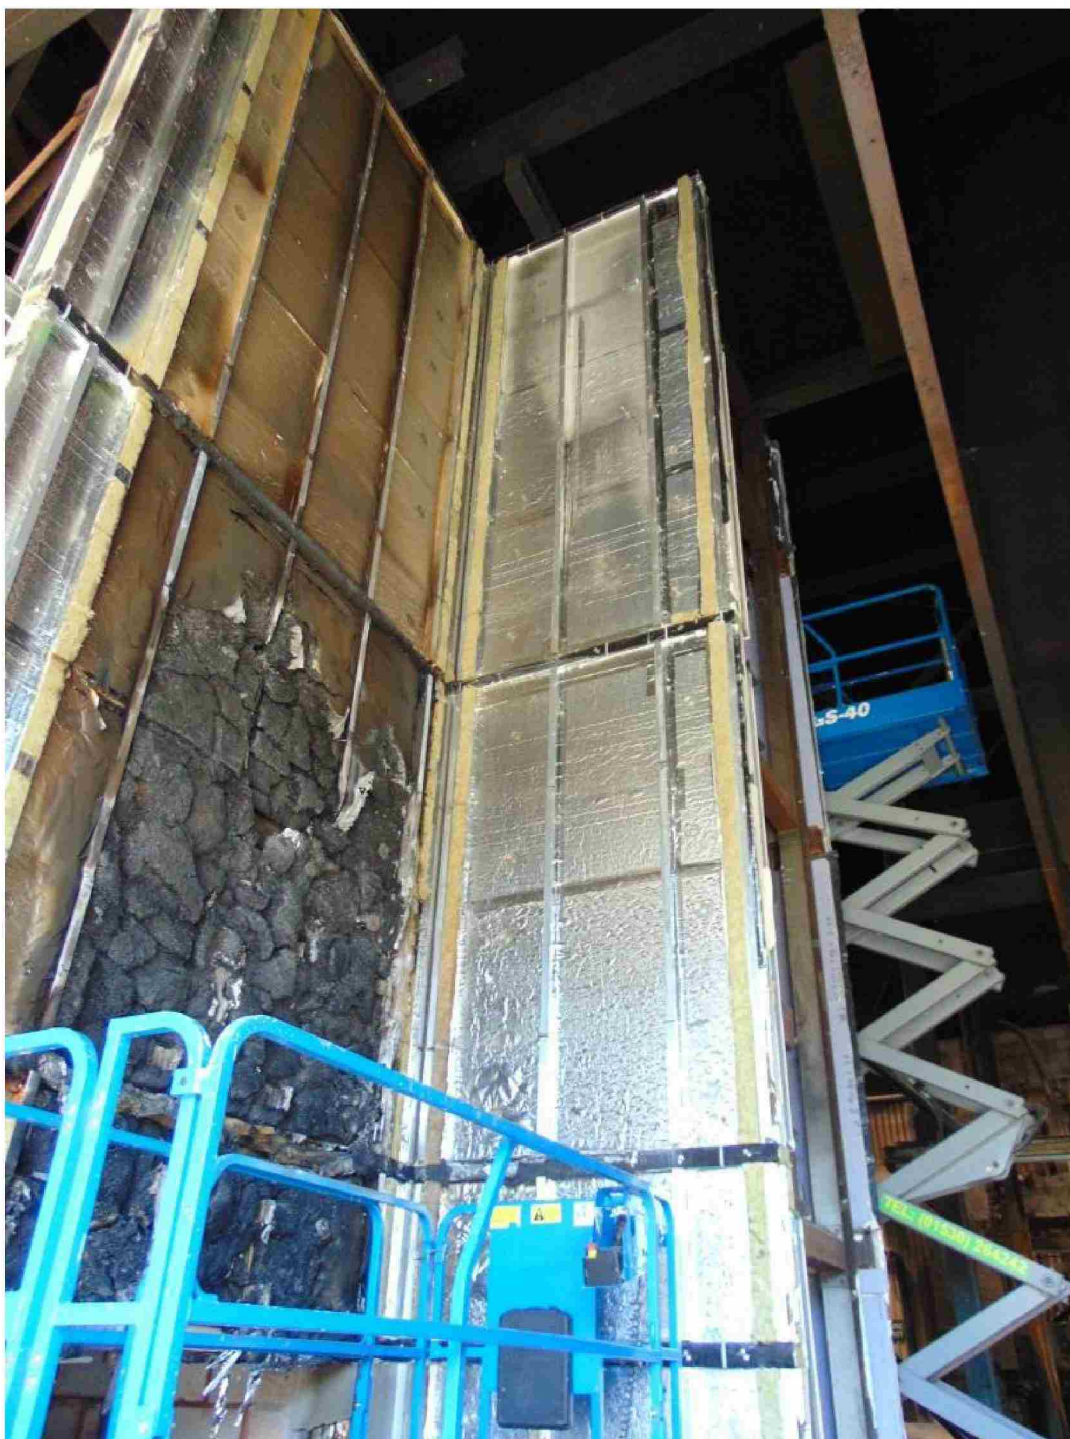
Figure 288. Post-test wing wall view of insulation, rail substructure and cavity barriers from the top of the combustion chamber to the top of the cladding system.

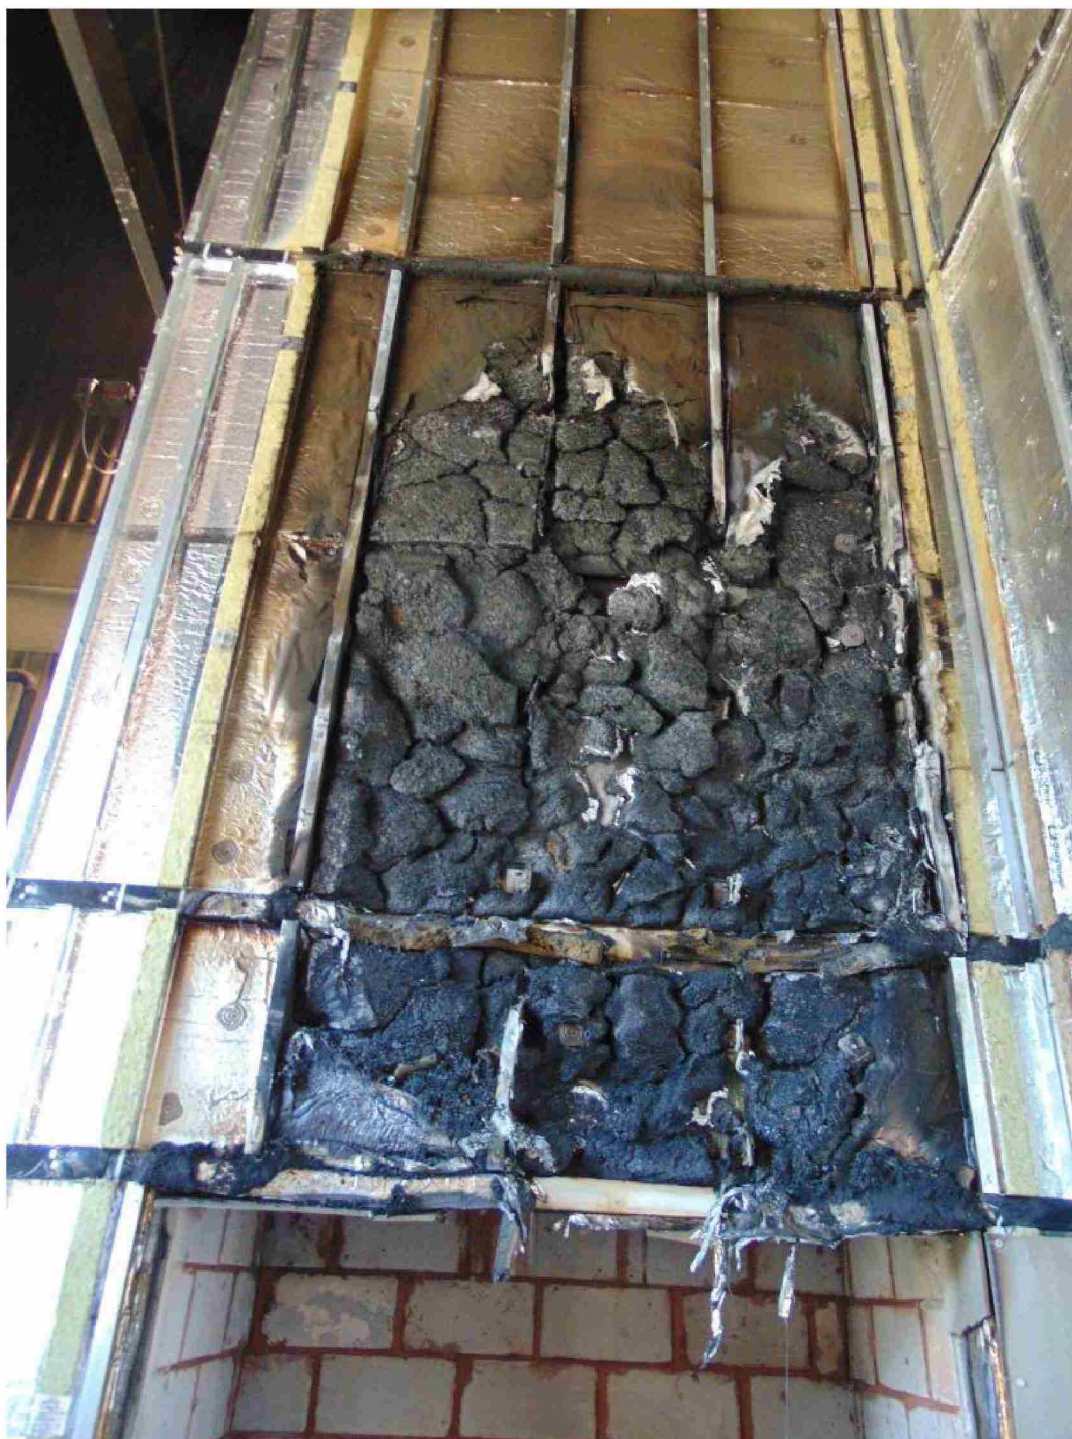
Figure 29. Post-test close up of main wall insulation, rail substructure and cavity barriers above the combustion chamber opening.

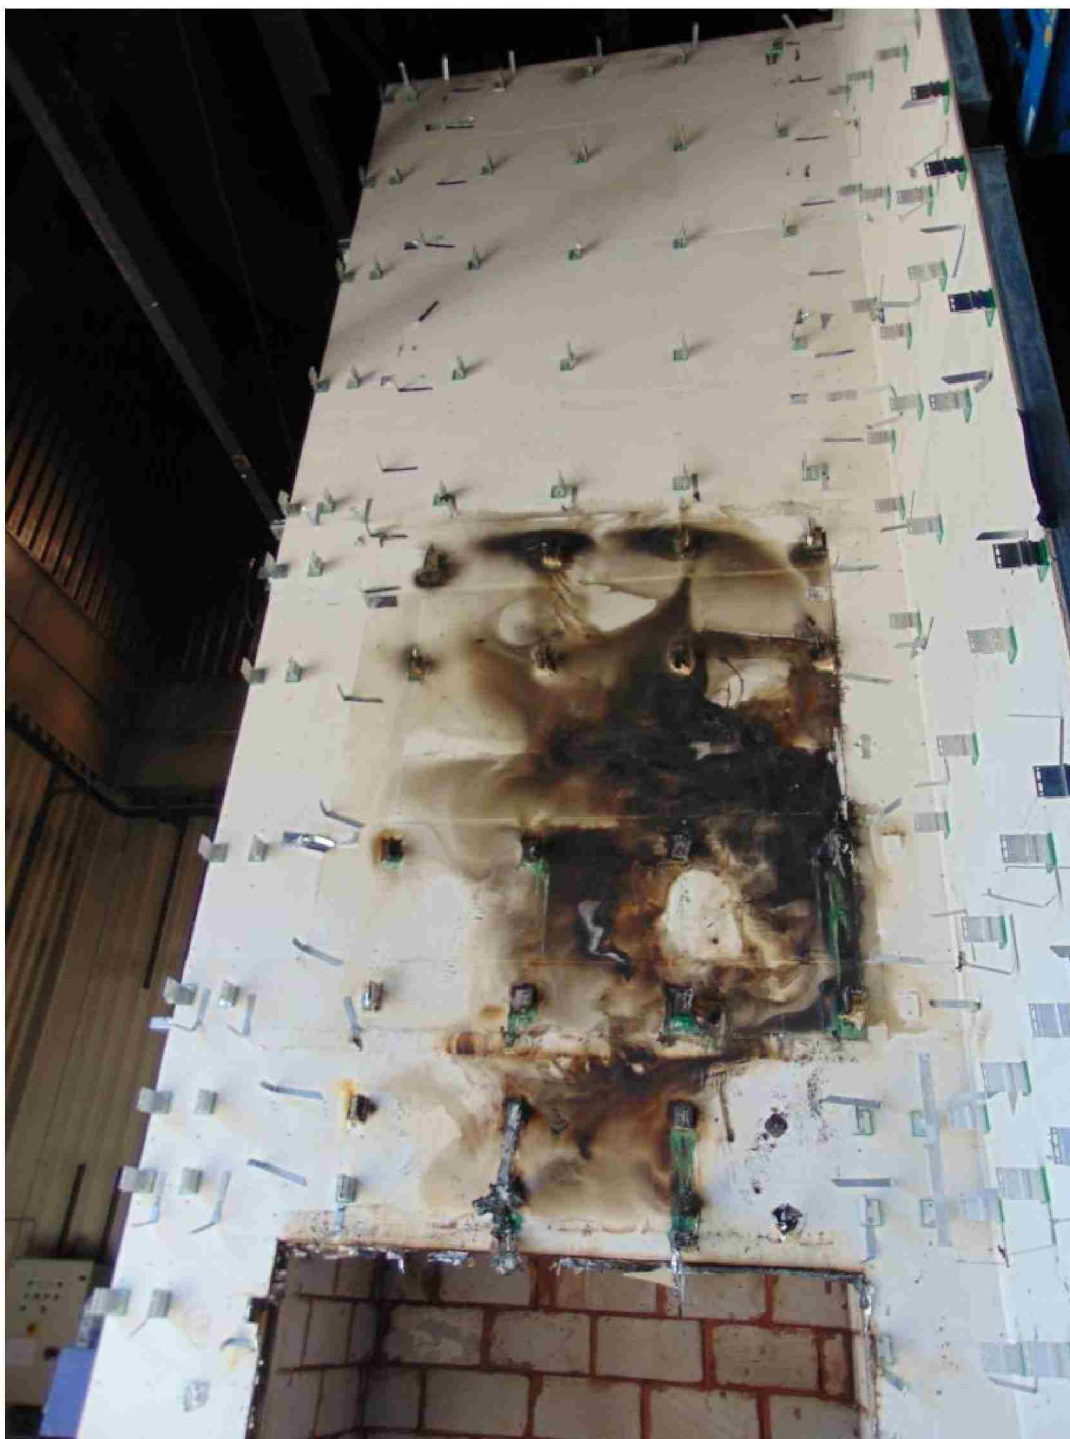
Figure 30. Post-test main wall view of sheathing board and brackets from the top of the combustion chamber to the top of the cladding system.

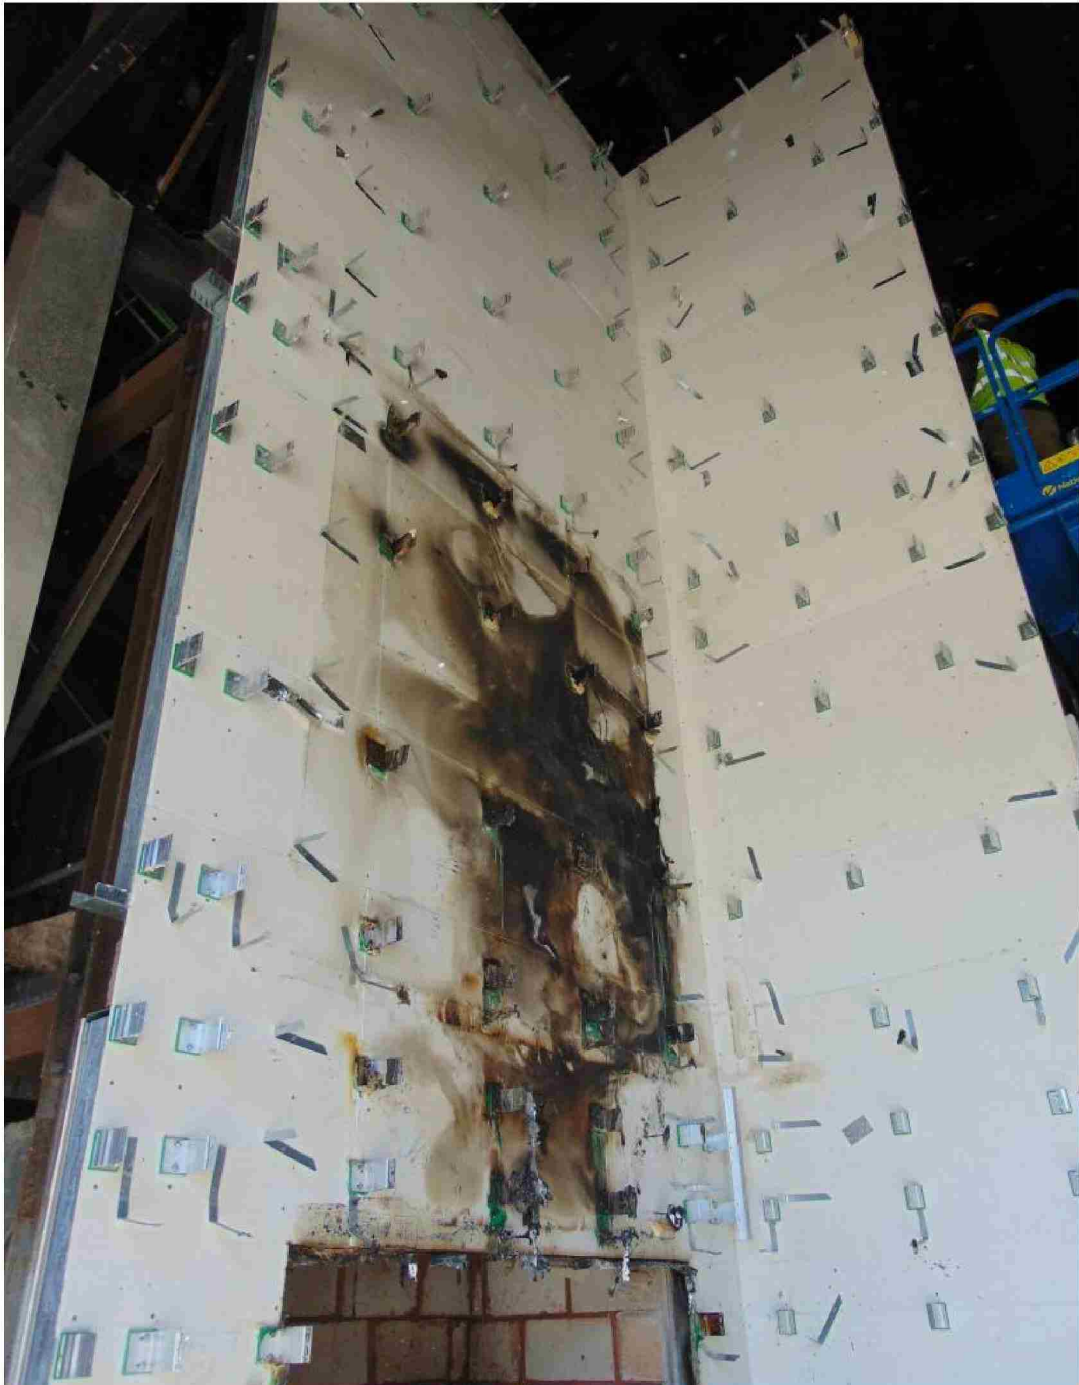
Figure 31. Post-test wing wall view of sheathing board and brackets from the top of the combustion chamber to the top of the cladding system.

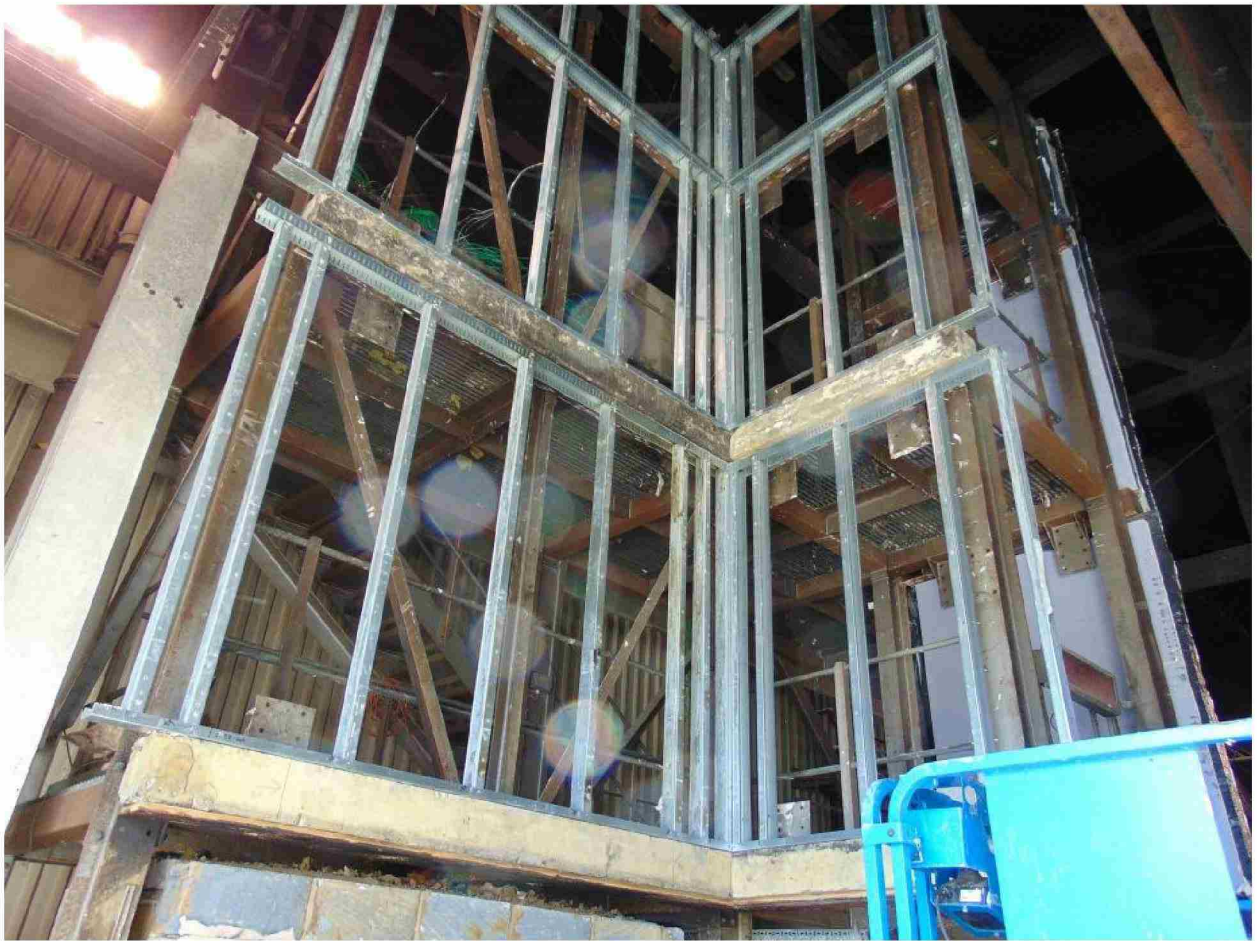
Up to the height of the second row of 'floor slabs' (approximately 3m above the combustion chamber opening) there were localised areas of dark and smoke discolouration. Above this there was no visible damage.

Figure 32. Post-test view of lightweight steel framing system from the top of the combustion chamber to the top of the cladding system.
