BRE Global Classification Report

Classification of fire performance in accordance with BR 135: 2013 Annex B for a ventilated Marley Eternit rainscreen system with Celotex RS5000 insulation

Prepared for: Celotex
Date: 02 May 2018
Report Number: P104852-1001 Issue: 1.0

Classification report No.: P104852-1001

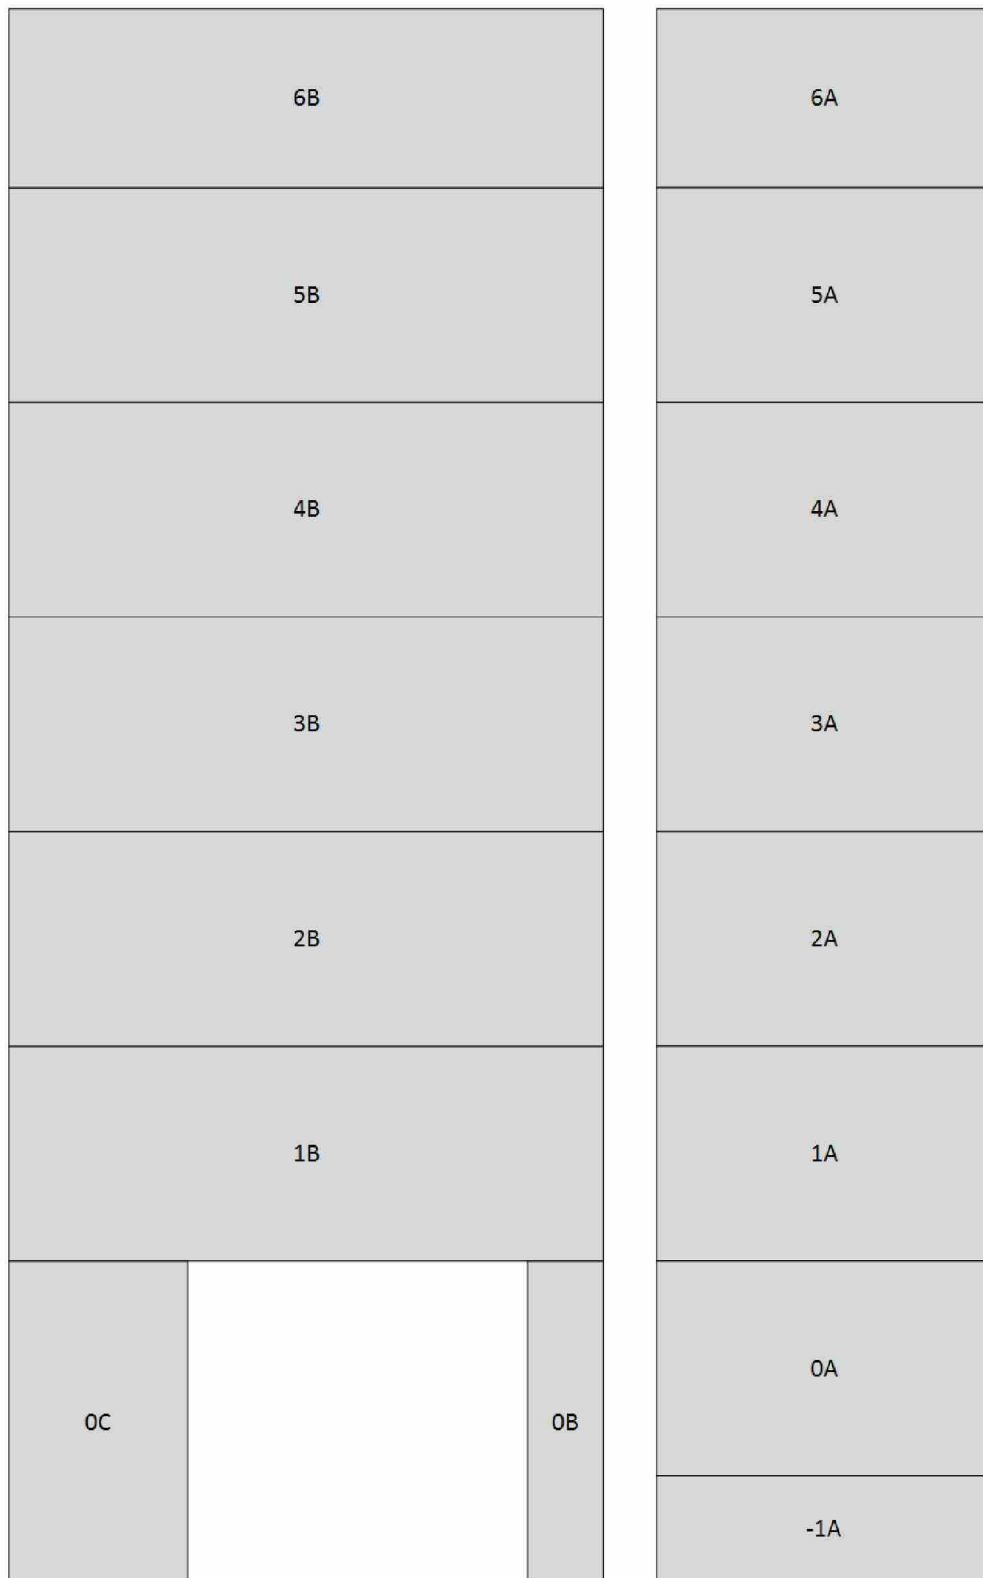
Figure 2. Layout of panels and numbering system used for reporting. Not to scale.

With reference to *Figure 2*, the damage observed to the Marley Eternit panels was as follows:

Panel 0A – 30% dark discolouration surrounded by brown discolouration, 30% pale discolouration with streaks of pale discolouration. A pattern of cracks was observed towards the main-wing wall junction.

Panel 0B – Mostly undamaged with light discolouration towards the top corner and dark discolouration towards the bottom corner adjacent to the combustion chamber opening.

Panel 0C – Mostly undamaged apart from a patch of light discolouration at the top corner adjacent to the combustion chamber opening.

Panel 1A – A patch of light discolouration (approximately 300mm-wide × 900mm-high) towards the main-wing wall junction surrounded by brown discolouration. Dark discolouration towards the edge of the wing wall. A pattern of cracks was observed towards the main-wing wall junction.

Panel 1B – Detachment of a central section approximately 800mm-wide × 1200mm-high (additional material detached after the end of the test). Light discolouration on the remainder of the panel surrounded by streaks of dark and pale discolouration. Patterns of cracks were observed on the remaining sections of the panel contained between the bounds of the combustion chamber opening.

Panel 2A – 20% dark discolouration towards the main-wing wall junction surrounded by brown discolouration.

Panel 2B – Detachment of a central section approximately 1200mm-wide × 1200mm-high. Light discolouration on the remainder of the panel surrounded by localised areas of dark discolouration. Patterns of cracks were observed on the remaining section of the panel adjacent to the wing wall.

Panel 3A – Brown discolouration towards the base of the panel local to the main-wing wall junction.

Panel 3B – Localised areas of dark and pale discolouration covering a width of approximately 2000mm towards the main-wing wall junction. Cracks were observed near the centre of the panels.

Panel 4A – 70% minor discolouration.

Panel 4B – 5% white discolouration at base surrounded by 20% dark discolouration. 60% smoke discolouration. Cracks were observed near the base of the panels.

Panel 5A – 40% minor discolouration.

Panel 5B – 80% smoke discolouration.

Panel 6A – 10% minor discolouration.

Panel 6B – 70% smoke discolouration.
